FACILITY STATUS CHANGE FORM

Date Submitted: 12-5-2012 Originator: David Warren Phone: (509) 539-6040	Area: 100-N Facility ID: 116-N Exhaust Air Stack Action Memorandum: 100-N Ancillary Facilities	Control #: D4-100N-0026
--	--	-----------------------------------

D4 Project Facility Completion Form

116-N Exhaust Air Stack Completion

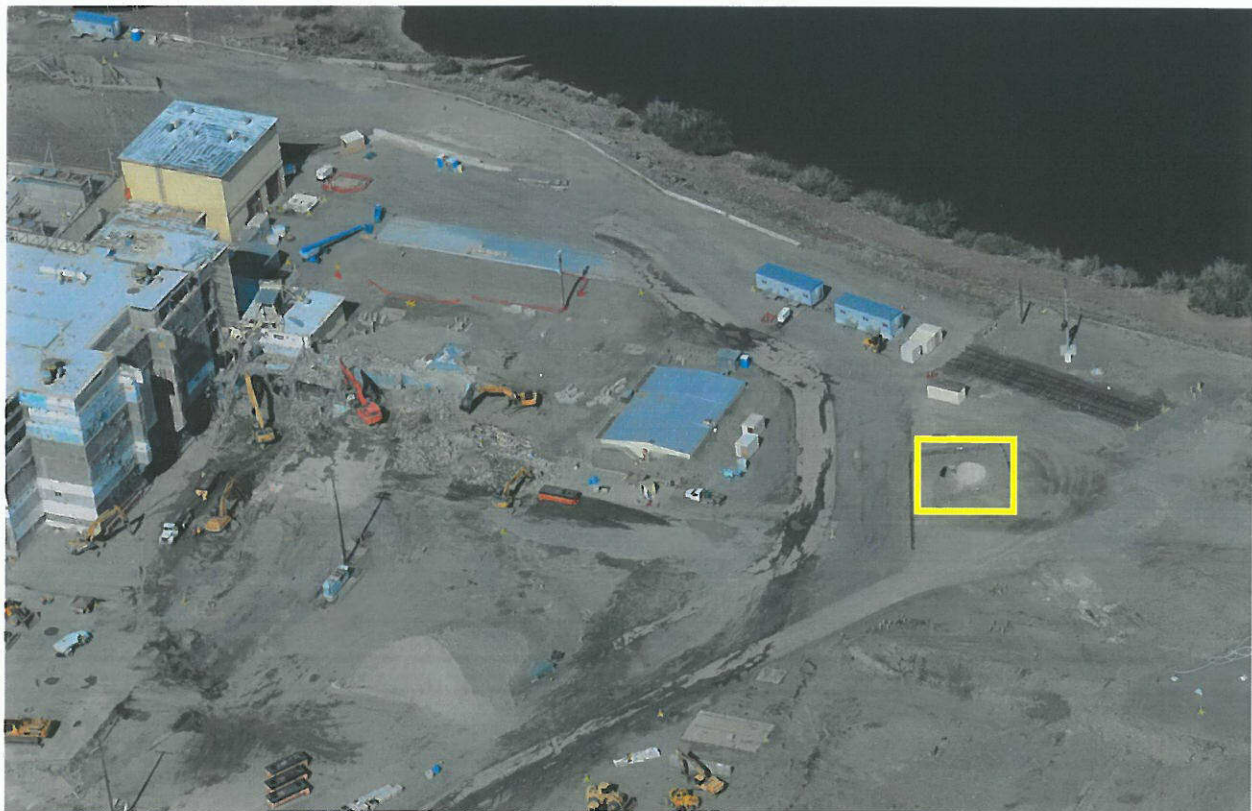
116-N Post-Demolition (Above Grade)

Demolition: Demolition of the above-grade structures began in September 2008 with explosive demolition and loadout of the above grade structure. Below grade demolition of the structure and loadout of the remaining debris was completed in January 2011. The contaminants of concern for demolition were radionuclides. Radiological and Industrial Hygiene survey results are included in Attachment 1. There were no anomalies encountered during the demolition of the 116-N Facility.

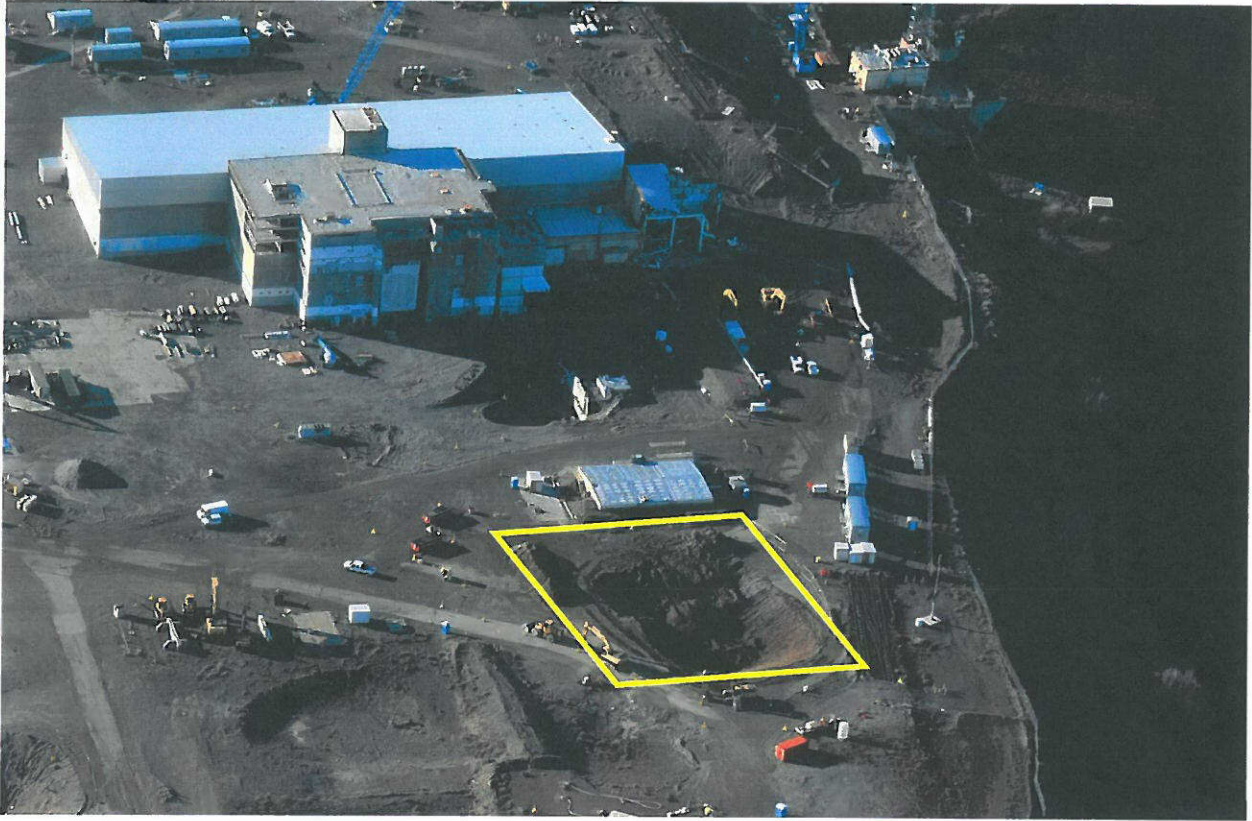
116-N Following Demolition & Excavation of the Below Grade Structures

Above grade demolition of the 116-N Exhaust Air Stack was completed in August of 2008. Below grade demolition, which included the stack foundation, was completed in January of 2011. The debris was loaded into roll-off containers and sent to the ERDF for disposal.

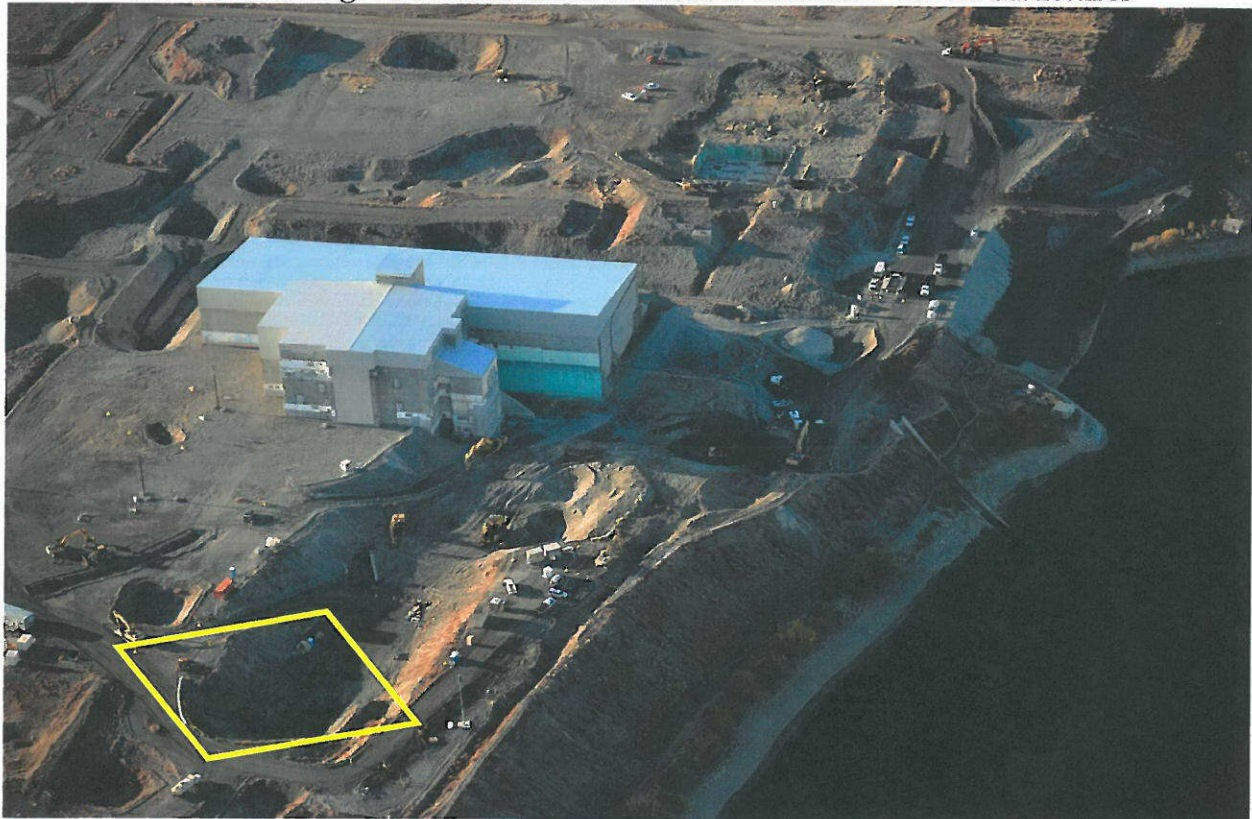
116-N Excavation as it appeared in October 2012

The 116-N excavation has not been backfilled and currently remains open. The excavation will undergo verification sampling by FR as part of the closeout process for 100-N-87, 100-N-102:1, UPR-100-N-9, and UPR-100-N-14.

No anomaly was encountered during demolition or removal of the 116-N Exhaust Air Stack. GPERS surveys and a visual inspection were performed at the 116-N excavation. No stained soil or radiological contamination was identified. Table 6 summarizes the contaminants of concern for 116-N demolition. Photographs are included in Attachment 2.
